DEPARTMENT OF TRANSPORTATION

Quality Assurance and Source Inspection

Contract #: 04-0120F4Cty: SF/ALA Rte: 80 PM: 13.2/13.9File #: 69.28**WELDING INSPECTION REPORT****Resident Engineer:**Pursell, Gary**Address:** 333 Burma Road**City:** Oakland, CA 94607**Report No:** WIR-013212**Date Inspected:** 05-Mar-2010**Project Name:** SAS Superstructure**OSM Arrival Time:** 700**Prime Contractor:** American Bridge/Fluor Enterprises, a JV**OSM Departure Time:** 1900**Contractor:** Zhenhua Port Machinery Company, Ltd (ZPMC), Changxing Island **Location:** Shanghai, China**CWI Name:** Geng wei**CWI Present:** Yes No**Inspected CWI report:** Yes No N/A**Rod Oven in Use:** Yes No N/A**Electrode to specification:** Yes No N/A**Weld Procedures Followed:** Yes No N/A**Qualified Welders:** Yes No N/A**Verified Joint Fit-up:** Yes No N/A**Approved Drawings:** Yes No N/A**Approved WPS:** Yes No N/A**Delayed / Cancelled:** Yes No N/A**Bridge No:** 34-0006**Component:** OBG Components**Summary of Items Observed:**

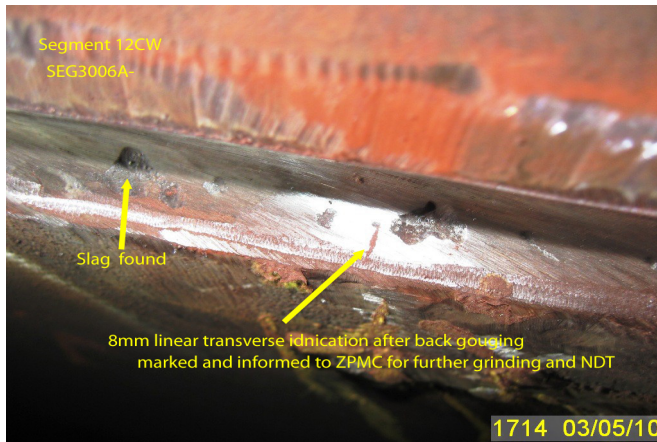
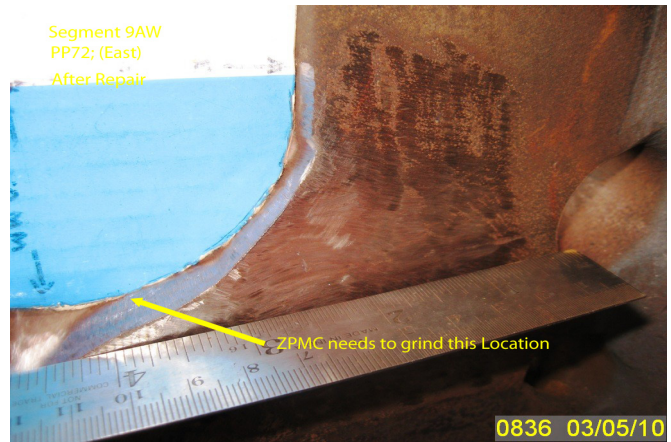
This QA inspector performed in process Visual Inspection of the below mentioned complete joint penetration weld between bottom plate and side plate of segment 12CW. During in process visual inspection of the above mentioned weld after back gouging and grinding, this QA observed one (1) transverse indication. SEG3006A-002.

- This was confirmed with MT wherein, One (1) transverse crack measuring approximately 8 mm length.

- This weld was previously Magnetic Particle Testing (MT) tested and accepted by ZPMC Quality Control (QC)

personnel after back gouging.

- This is informed to ZPMC QC for further grinding and future NDT follow-up before welding. No incident report written for this incident.
